2013–2016 Hyundai Santa Fe Sport/Sonata and Kia Optima/Sportage 2.0 L4 Engine Turbocharger 2511469 & Oil Feed Line 2541276

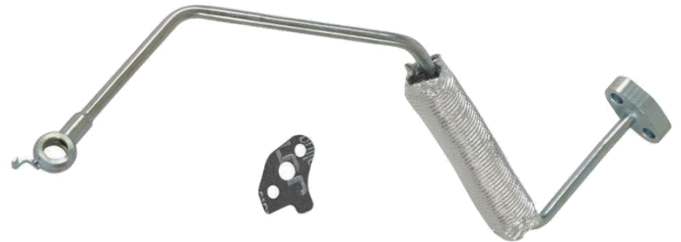
2541276 · Oil Feed Line

These models are known for burning oil, a buildup of carbon inside the oil feed line, or lack of oil, will damage the turbocharger with lack of lubrication. In most cases, flushing is ineffective for this type of restriction. Thus, the oil feed line should be replaced to ensure necessary oil flow and lubrication of the turbo unit. As lack of lubrication is detrimental to turbo performance, failure to replace the oil feed line in this scenario can cause various turbo failures. It should also be noted that turbo failure due to restricted oil feed line is not covered under the manufacturer's warranty.

When installing a new turbo unit on 2013–2016 Hyundai Santa Fe Sport/Sonata and Kia Optima/Sportage 2.0 L4 engine models, gpd highly recommends replacing the oil feed line.
