2007–2019 Nissan Compressor Wiring Harness Troubleshoot

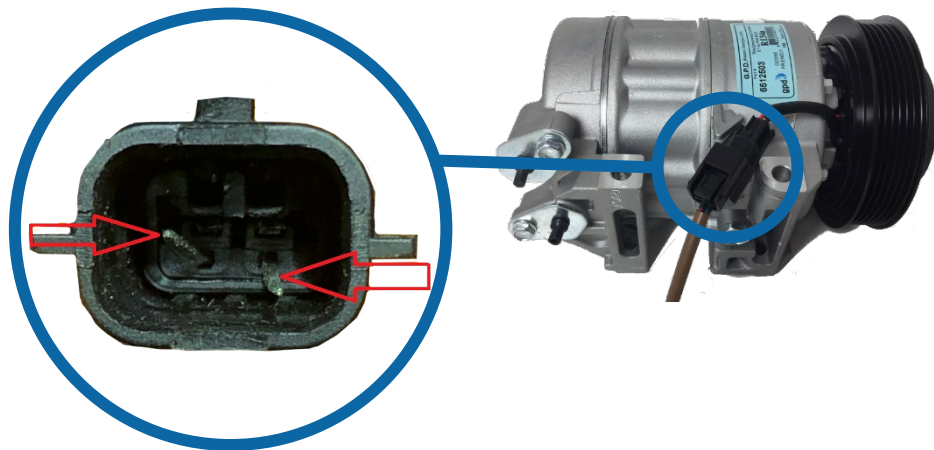
A common issue has been noted regarding the OE electrical connector/compressor pigtail on late model Nissan vehicles. The electrical connector (on the wiring harness side that plugs into the compressor) becomes loose after being separated and plugged back in. This electrical issue often leads to a malfunctioning A/C system.

Thoroughly inspect the wiring harness connectors before installing. Make sure to inspect the terminal inside of the electrical connector. In some cases, the terminals

1712339
gpd Compressor Pigtail Replacement
