1999–2020 Chevrolet Express Van/GMC Savana Blower Motor Speed Selection Troubleshoot

TECH TIP

#88

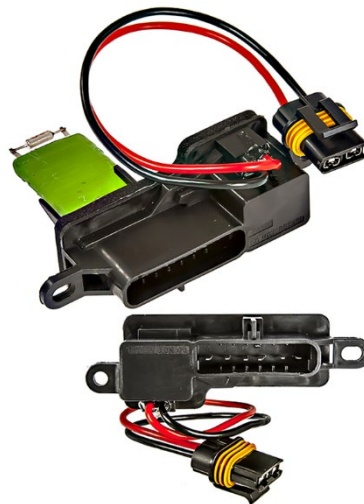
1712229
Blower Motor Resistor

Blower motor resistor 1712229 is a direct fit blower motor resistor replacement with two hole mounts.
