2014–2018 BMW X5 and 2015–2018 BMW X6 Blower Motor Equipped with Resistor: 2312001

TECH TIP

#161

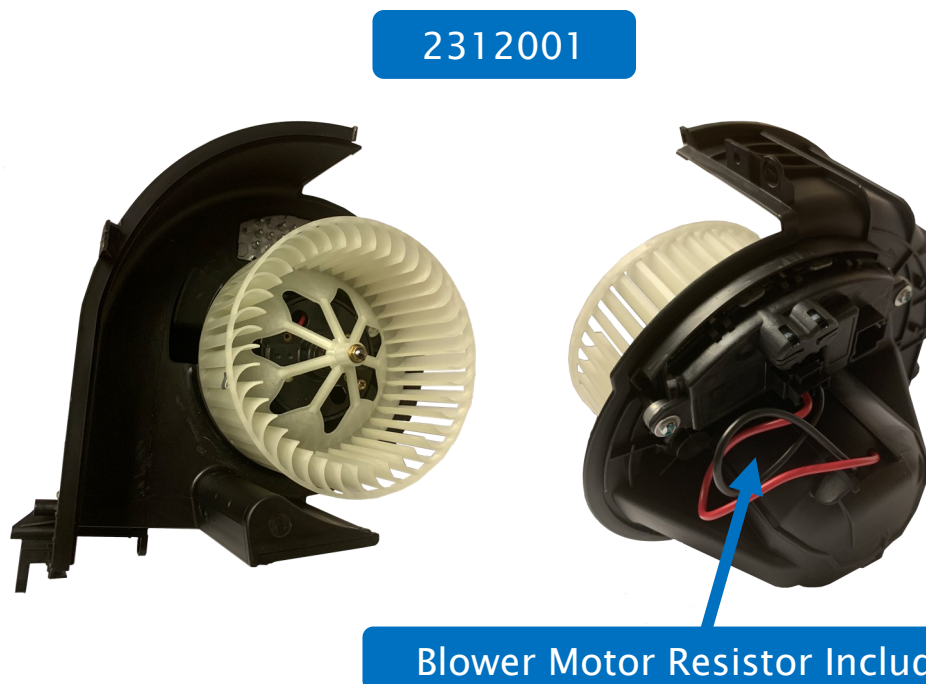
gpd blower motor #2312001 for 2014–2018 BMW X5 and 2015–2018 BMW X6 comes fitted with the blower motor resistor.

A common reason for blower motor failure is a faulty blower motor resistor. The blower motor resistor controls the speed of the blower motor to reduce/increase air flow based on A/C control commands. Most blower motors do not come equipped with the blower motor resistor; it is usually purchased separately. It is best practice to check/replace the blower motor resistor and connector/relay when replacing the blower motor. Considering the time to replace a blower motor takes approximately 2–3 hours, making these replacements a nominal cost and easy preventative measure.
