Compressor Micro Pin Connectors

TECH TIP

#130

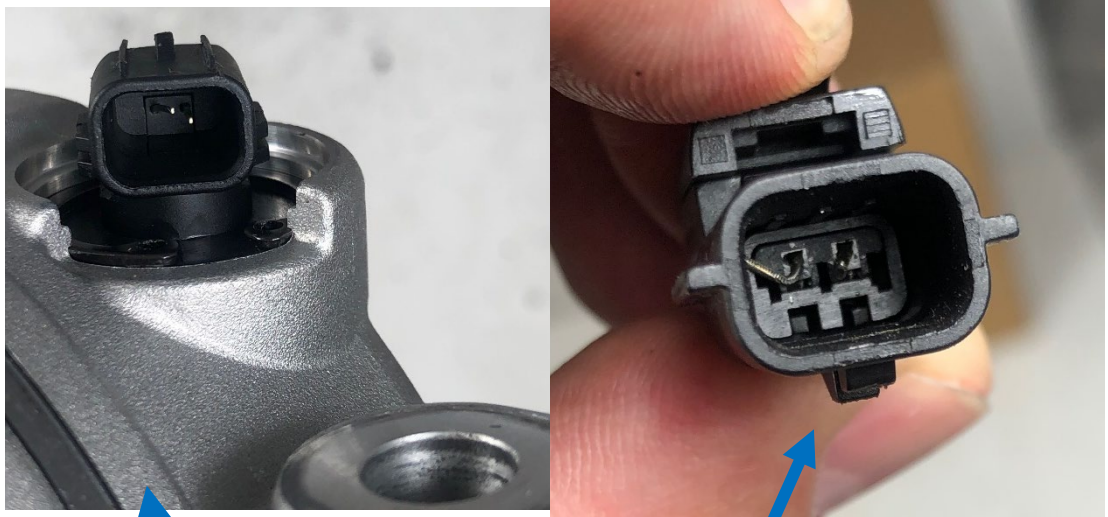
Shown above are micro pin connections that have been bent, preventing an electric current to the compressor. If not repaired/replaced, the compressor will appear inoperative.

As vehicle technology advances, many electronics are designed to be more compact. Many electronic A/C components fall under these design changes. The miniaturization of male micro pin connectors makes them more susceptible to damage. If care is not taken when connecting terminals together, the pins in these connectors may bend. This could interfere with the electric current to the compressor. If faced with this situation, disconnect the micro pin and check that the connecting pins are not bent.

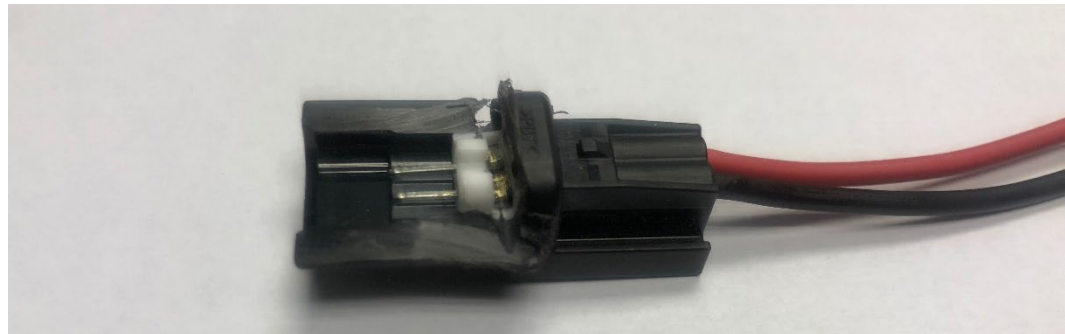
Shown above is an undamaged male micro pin connector.
