## 2015–2020 Ford F–150 and 2017–2020 Ford F–250/350/450 Super Duty Evaporator & Thermistor Service Precaution

TECH TIP

#221

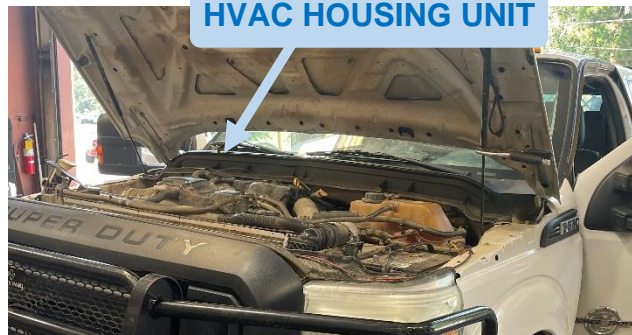
**Figure 1.1**  
*2017 Ford F-350 Super Duty*

The thermistor (also known as the evaporator temperature sensor or anti-ice sensor) reads and sends temperature readings to the A/C control module to regulate passenger A/C temperature. The thermistor is generally located in the under-dash HVAC housing unit, attached to the evaporator and is generally accessible at the engine firewall or by removing the dash to expose the HVAC housing unit behind the glove box. (Figures 1.1 and 1.2)

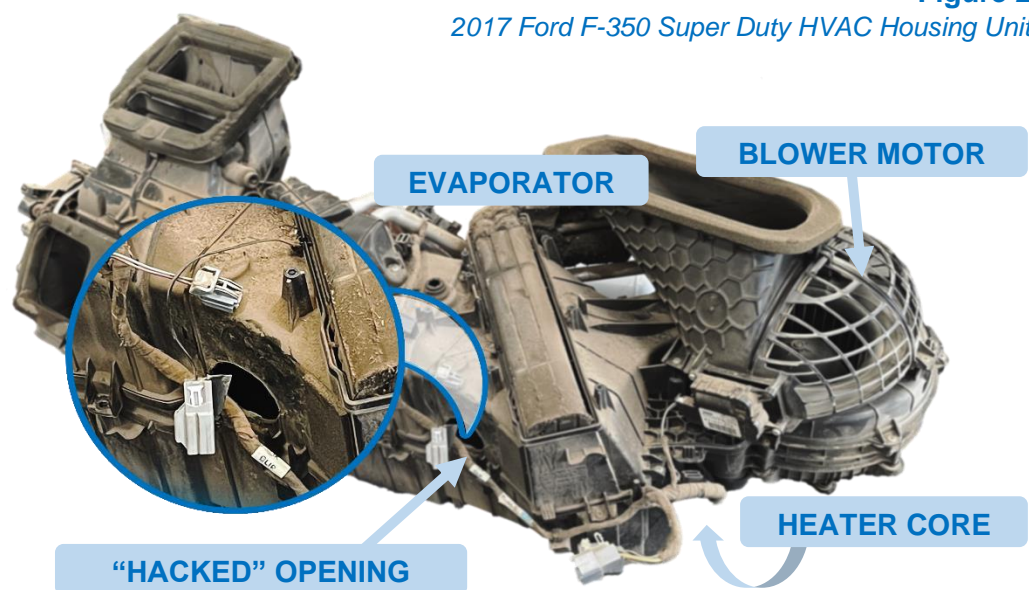
**Figure 2**  
*2017 Ford F-350 Super Duty HVAC Housing Unit*

As a work around to the time intensive task of removing the dash to access the thermistor and evaporator in the HVAC housing unit, there is a popular DIY “hack” where a hole is cut into the plastic HVAC housing unit to access the thermistor (Figure 2). While this “hack” is effective in some cases, please note:

- Failure to re-seal the HVAC housing unit exposes the thermistor, evaporator, heater core, and blower motor to environmental debris which can cause damage and/or audible noise in the passenger cabin.
- Failure to re-seal the HVAC housing unit also alters air flow and temperature, which will further hinder performance of the temperature control system.
- Changing the original position or modifying the thermistor can also hinder performance as the climate control system is relying on temperature readings from the thermistor for optimal performance.

- If a hole is cut into the plastic HVAC housing unit, gpd highly recommends using a plastic welder to seal the “hacked” opening.
