# 2011–2017 Nissan Juke 1.6 L4 Engine Turbocharger 2511519 & Oil Feed Line 2541237

**TECH TIP**

#210

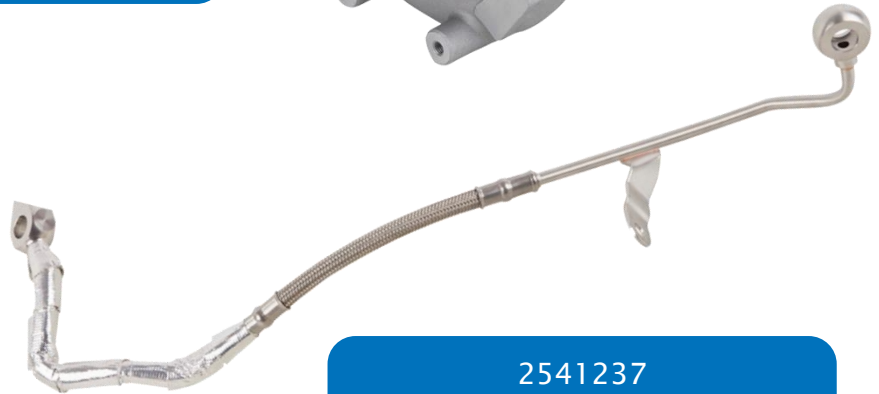
2541237  
2011–2017 Nissan Juke  
Oil Feed Line

These Nissan Juke models are designed with the oil feed line close to the exhaust. Excessive heat from the exhaust accelerates the breakdown of inner hose material, creating a restriction in the oil feed line. In most cases, flushing is ineffective for this type of restriction. Thus, the oil feed line should be replaced to ensure necessary oil flow and lubrication of the turbo unit. As lack of lubrication is detrimental to turbo performance, failure to replace the oil feed line in this scenario can cause various turbo failures. It should also be noted that turbo failure due to restricted oil feed line is not covered under the manufacturer's warranty.

When installing a new turbo unit on 2011–2017 Nissan Juke 1.6 L4 engine models, gpd highly recommends replacing the oil feed line.
