A/C Service Tips for 2002–2005 Mercury Mountaineer 4.6 V8 Gas Engine

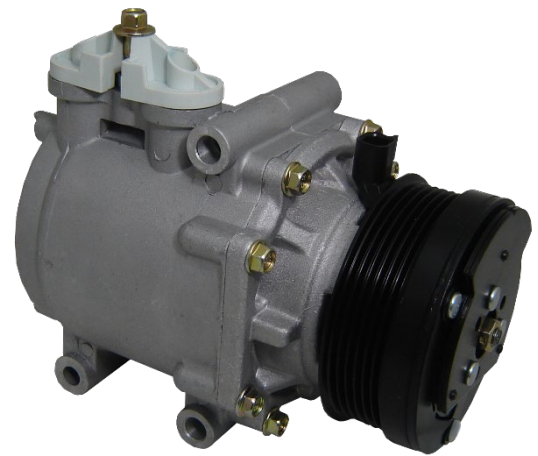
6511472 • Scroll • 6 Groove
(With or without rear A/C)
