Replacing Parallel Flow Condensers When a Compressor Fails

TECH TIP

#58

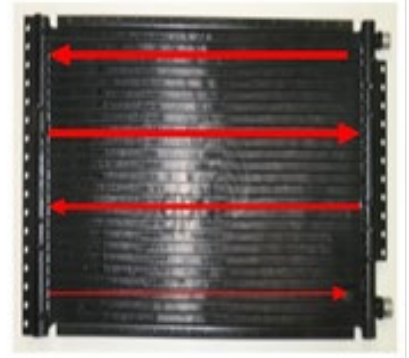
This is done by making the refrigerant change direction by 180° at the end on the side rails by placing a plug inside the rail at intervals, forcing the refrigerant change directions. The more plugs, the more times the refrigerant changes direction. In most condensers the refrigerant makes three to four "passes" through the condenser.

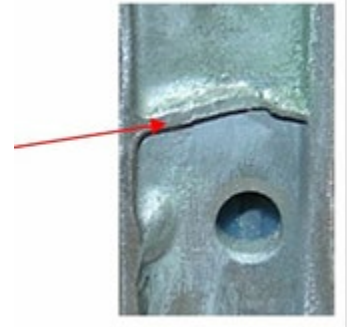
Parallel flow condensers don't have a large hollow tube that the refrigerant flows through, but a series of very small tubes close together in a row with the internal diameter about the size of a pin head. This helps to improve the surface area of the condenser and increase its cooling capacity.

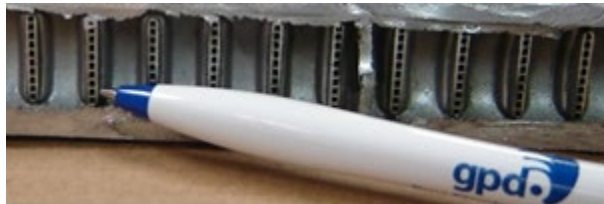
When a compressor fails it introduces contaminants into the system, one of the easiest ways to spot this is to remove the orifice tube that usually reveals metal deposits or sludge from a faulty compressor. The metal and sludge gets deposited throughout the system and will collect at places in the system with restrictions, like the orifice tube and on later model vehicles, the parallel flow condensers.

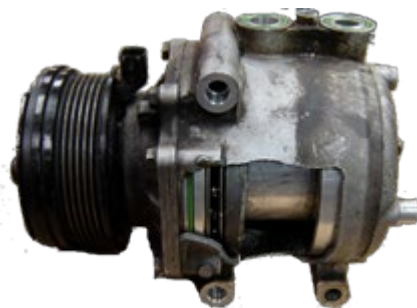
While flushing the system can help to remove debris from part of the system, items with small openings, like the parallel flow condenser are going to collect the debris. Flushing them will only push the contaminants further into the condenser and will collect at the plugs in the side rails, reducing the amount of rows available to cool the refrigerant and slowing the flow of the refrigerant, this leads to high head pressures. Combine it with a high efficiency compressor, like a scroll and not only will the replacement

When confronted with a compressor failure on a vehicle fitted with a parallel flow condenser, we recommend that the technician replace the accumulator, orifice tube or expansion device and condenser. We also recommend that all other components are flushed to ensure they are free of contaminants that could harm the new compressor.
